#### NATIONAL TRANSPORTATION SAFETY BOARD

## **ERRATA TO PERFORMANCE STUDY**

## Specialist's Report of Investigation By Abdullah K. Kakar

## **DCA05MA004**

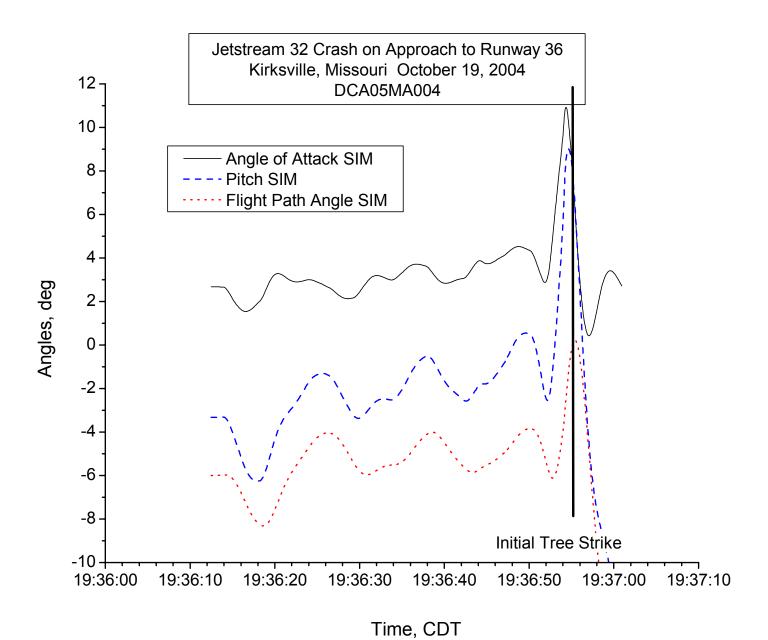
Figure 15 is a plot of the airplane's angle of attack, flight path, and pitch angle, which shows that the airplane's flight path angle was fairly constant at approximately minus 5 degrees and below the typical minus 3 degree glide path angle. The angle of attack shows an increase to about 11 degrees just prior to the initial tree strike.
